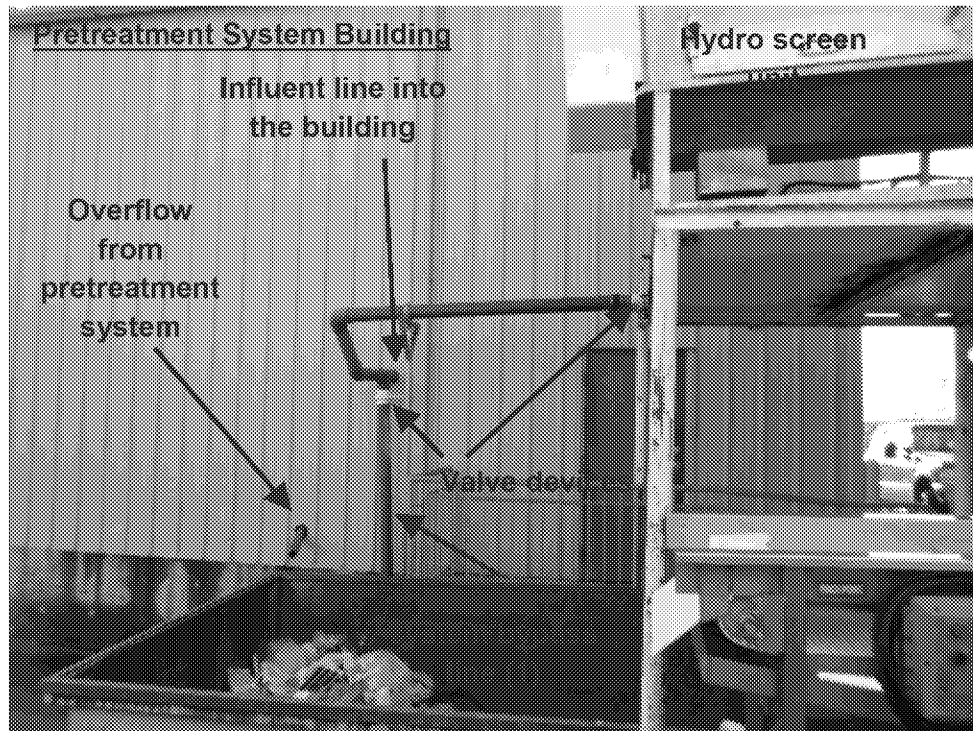
Photograph 1. View of the Hydro screen, its effluent piping, and two isolation valves in the effluent line. The hydro screen is immediately upstream of the Pretreatment System Building.

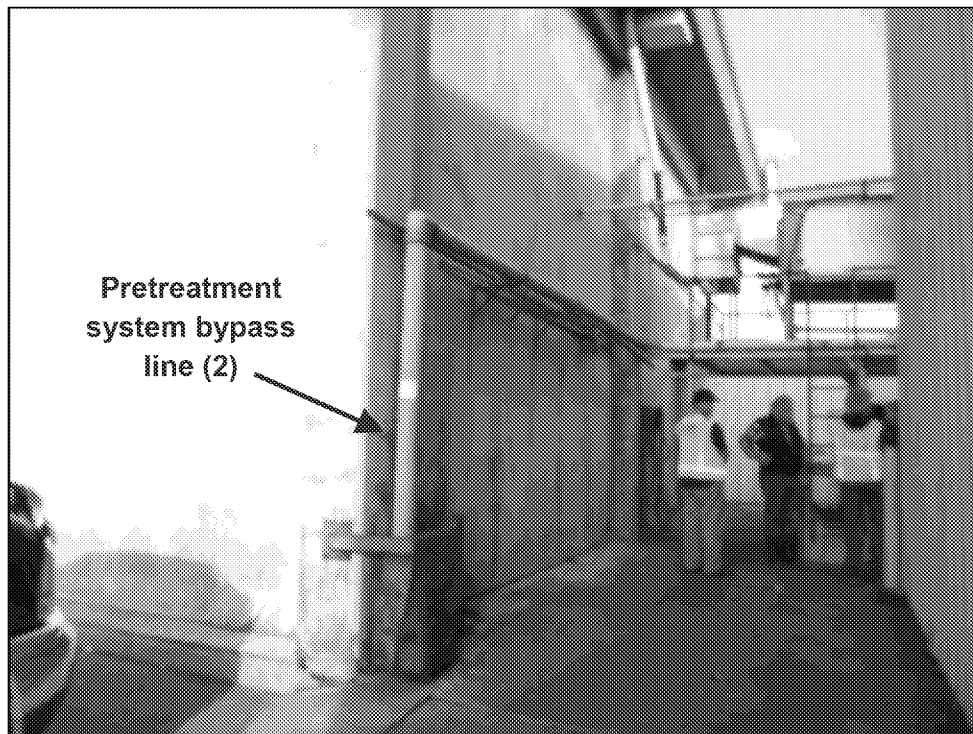
Photograph 2. View of the secondary discharge route of wastewater from the hydro screen. This route bypasses the pretreatment building.

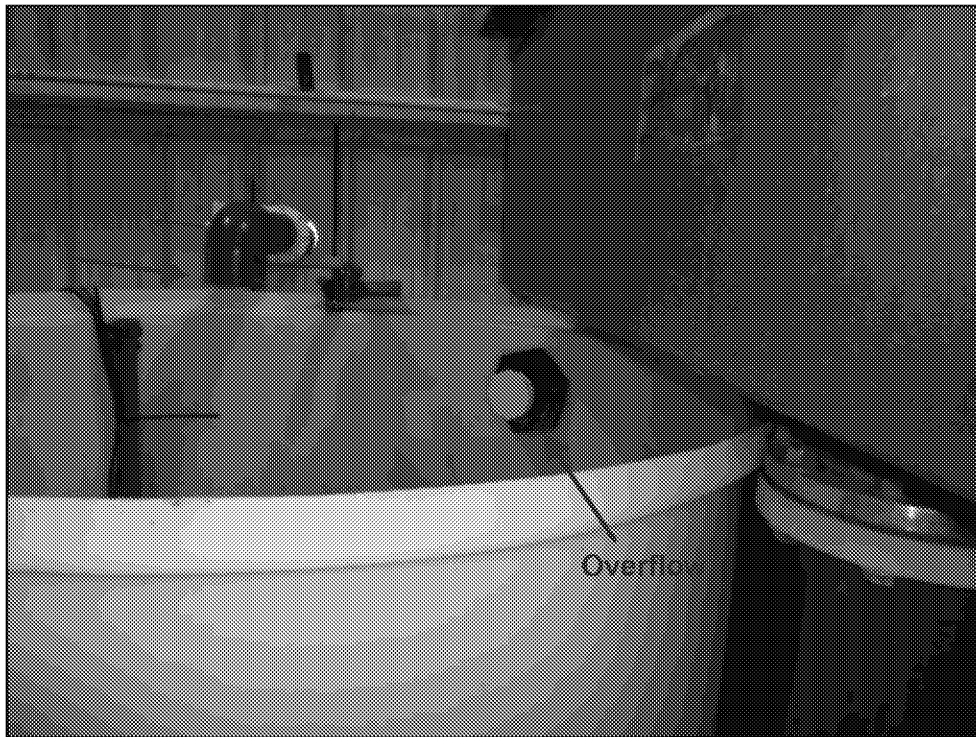
Photograph 3. View of the initial holding tank. The tank had an overflow pipe to the exterior of the building. It's unclear if the overflow was capped or if it was a screening or flow restrictor.

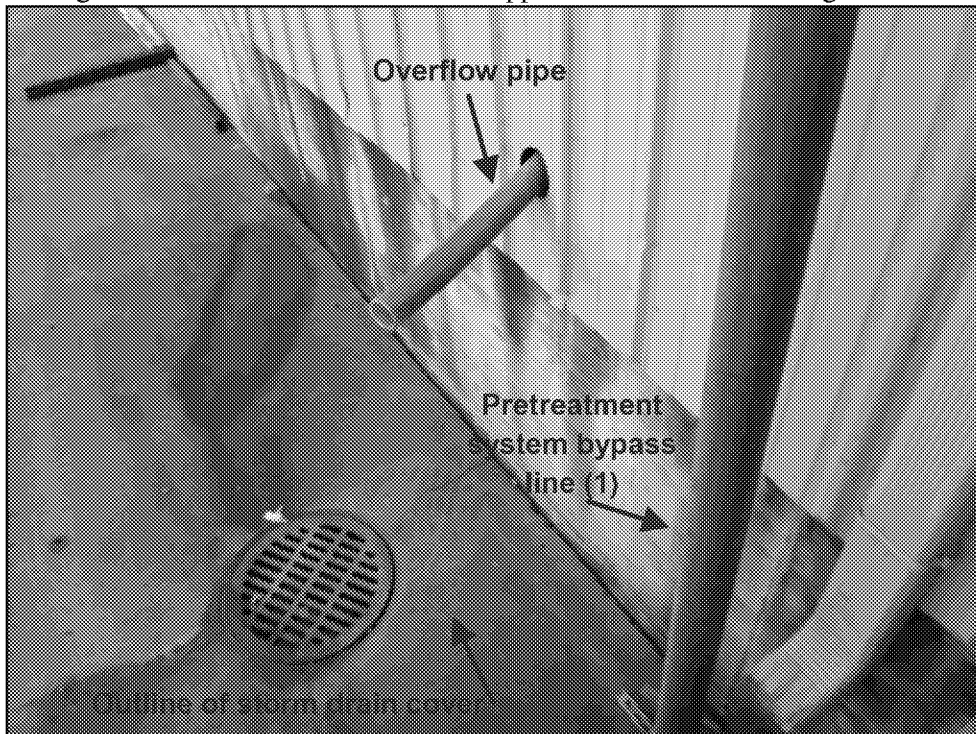
Photograph 4. View of the overflow pipe from the initial holding tank. The drain shown in the photograph appeared to be a storm drain.

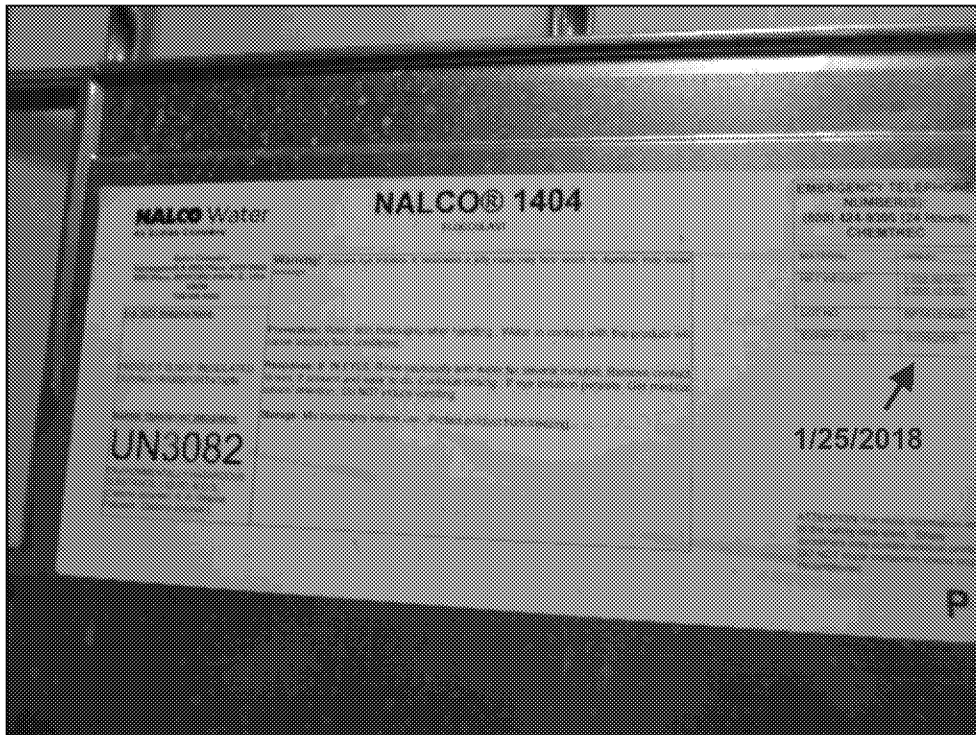
Photograph 5. View of the flocculant stored in the pretreatment building. The expiration date noted on the label was January 25, 2018.

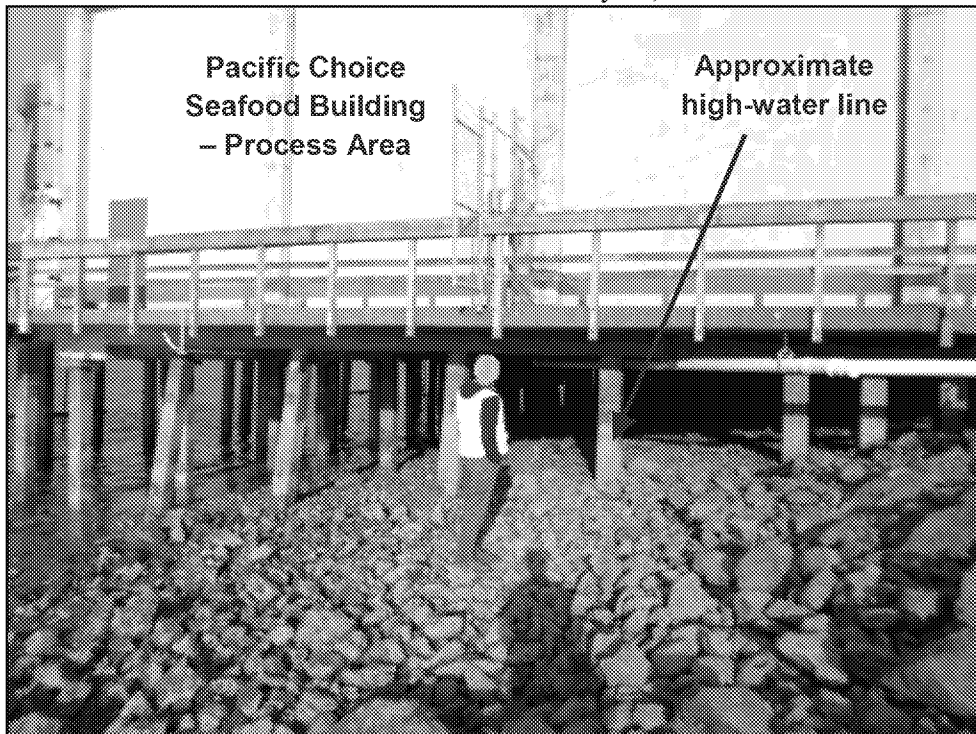
Photograph 6. View, facing east, of the west side of Pacific Choice Seafood. Note approximate high-water line showing the extent of the tidal influence.

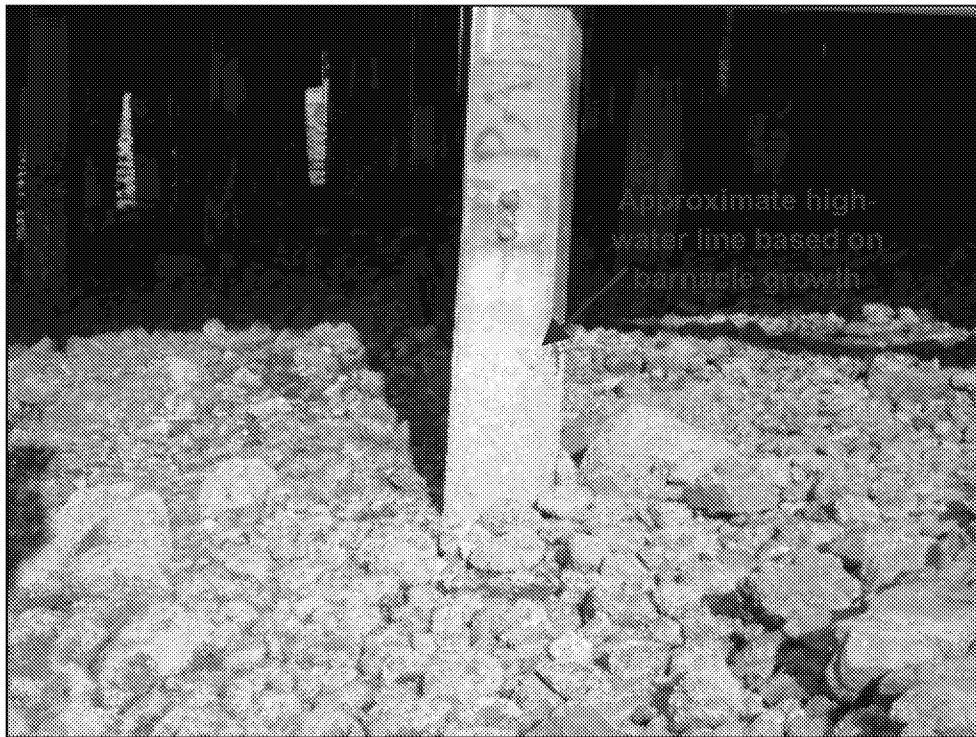
Photograph 7. Close-up view of the approximate high-water line shown in Photograph 6.

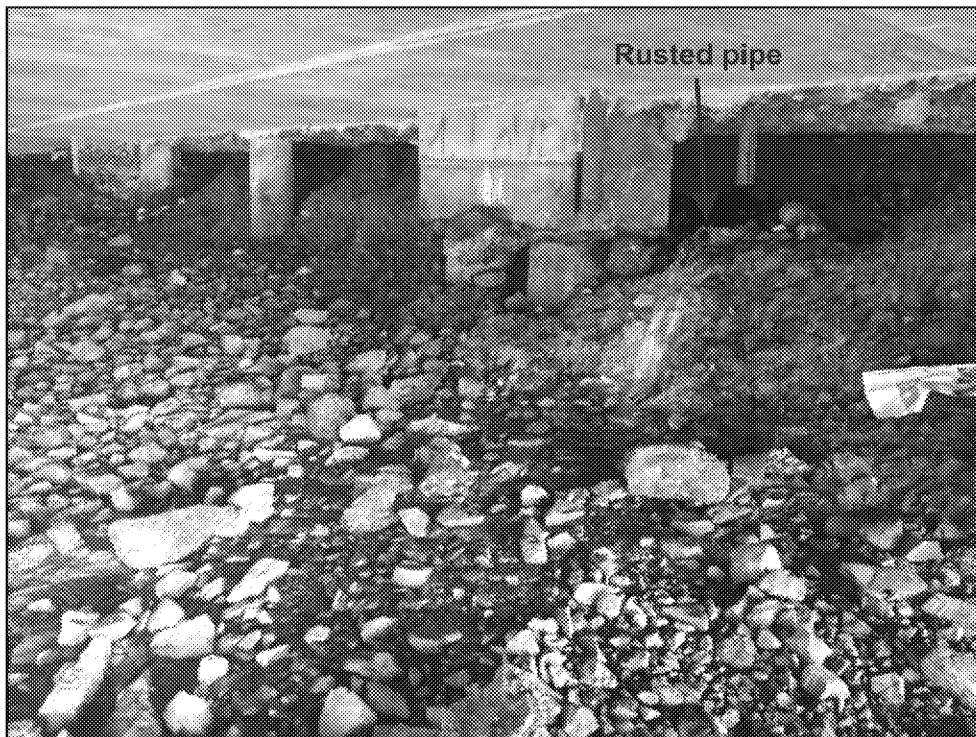
Photograph 8. View of a rusted pipe underneath the facility that was discharging water onto the ground. The water then flowed to the Eureka Slough.

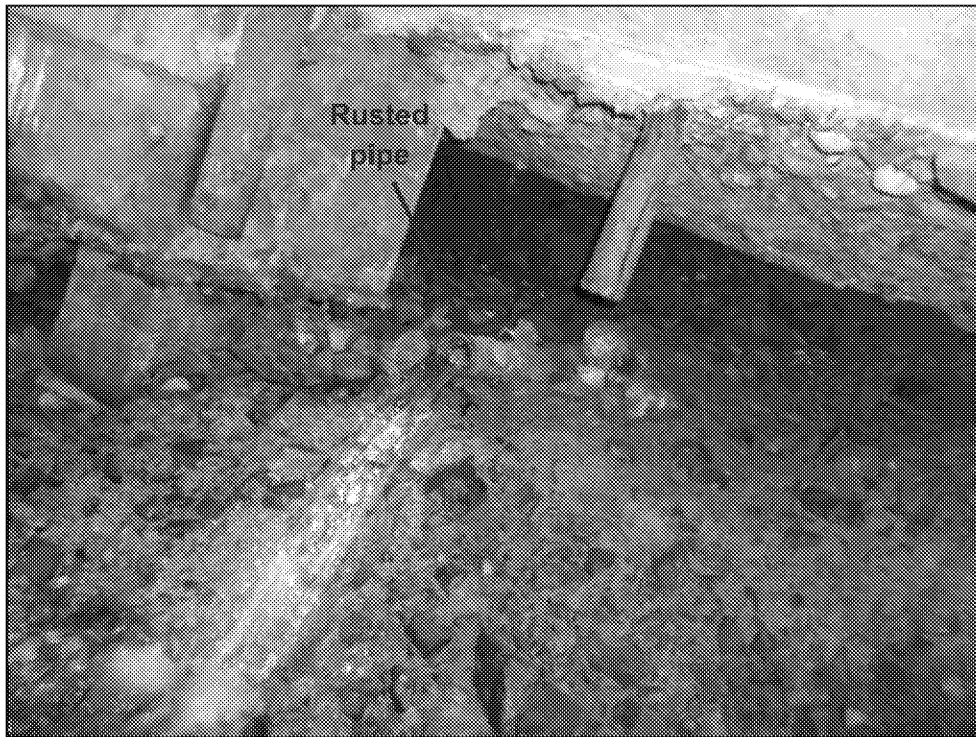
Photograph 9. Close-up view of the rusted pipe shown in Photograph 8. It's unclear where this pipe was connected to the sewer in the past, no sewer pipe or other infrastructure was observed downstream of this pipe.

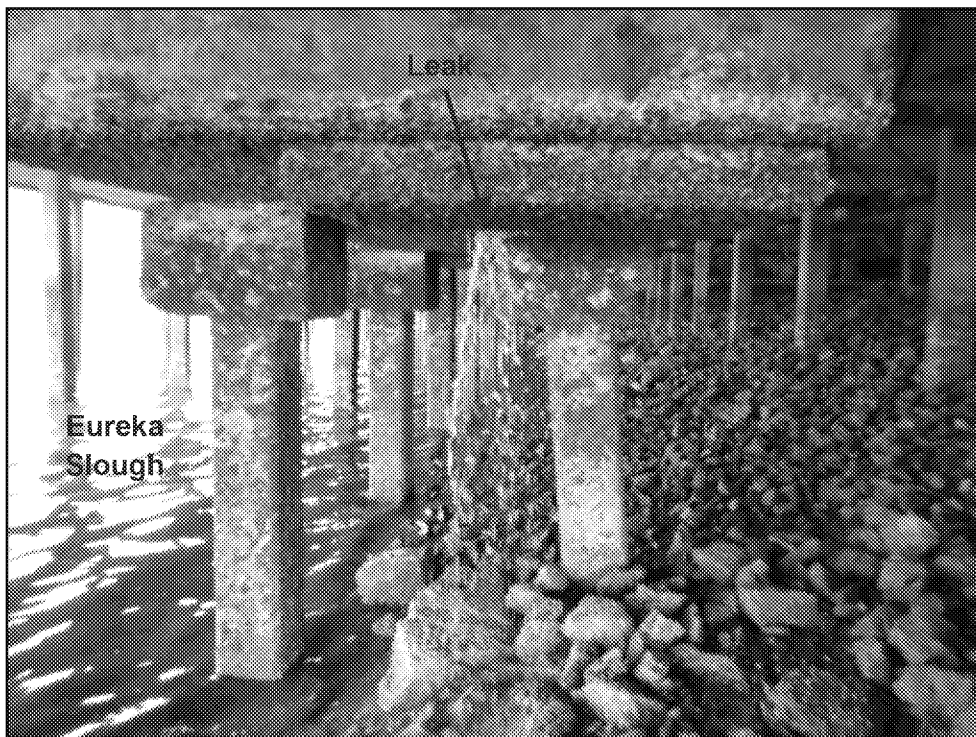
Photograph 10. View of unidentified leak underneath the facility.

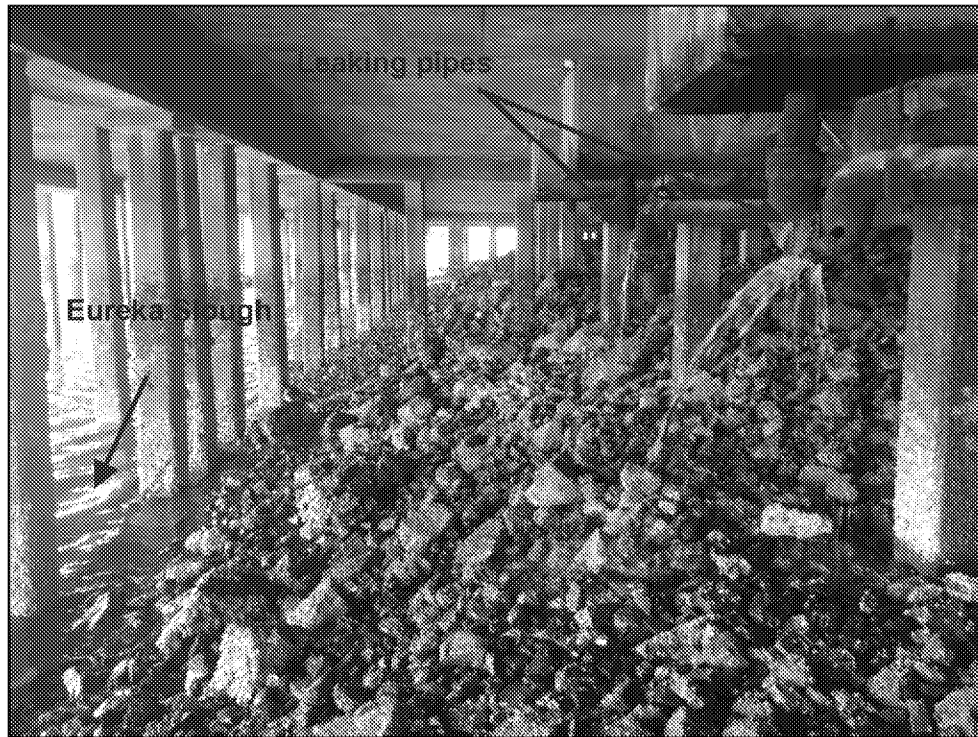
Photograph 11. View of leaking pipes underneath the facility. The water flowed to the Eureka Slough.

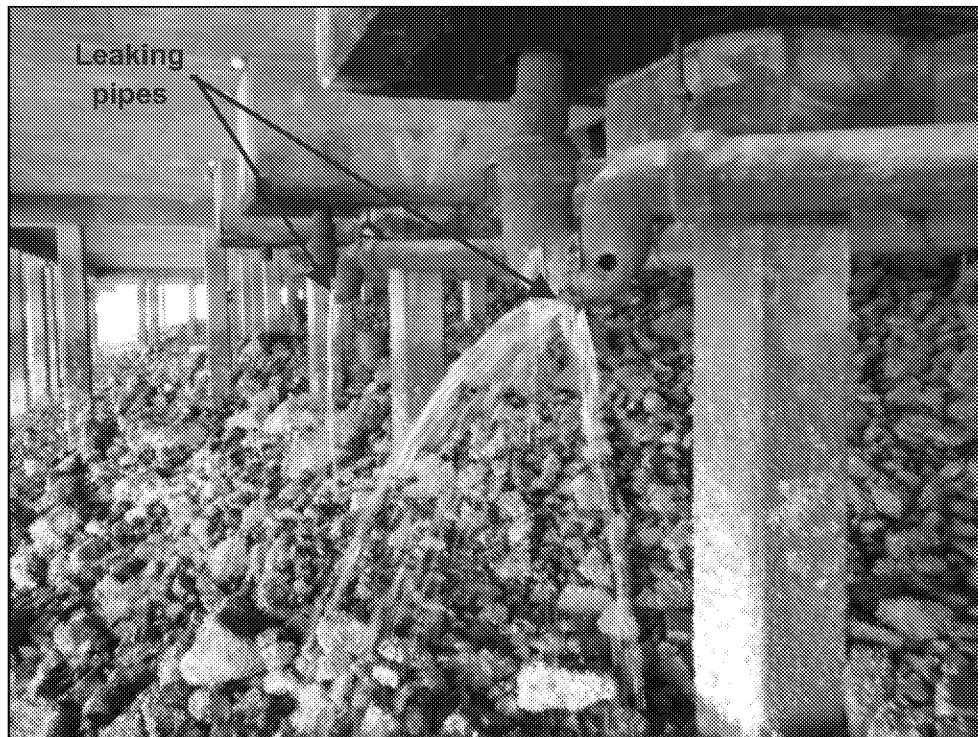
Photograph 12. Close-up view of leaking pipes shown in Photograph 14.

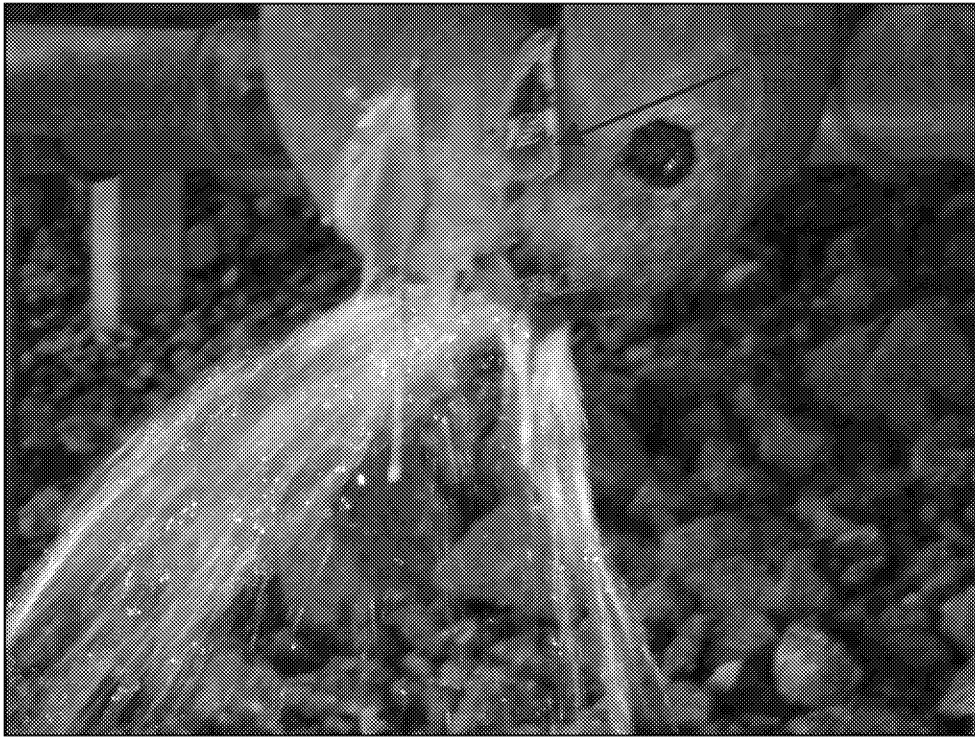
Photograph 13. Close-up view of leaking pipe shown in foreground of Photograph 12. Black tape was present on the pipe.

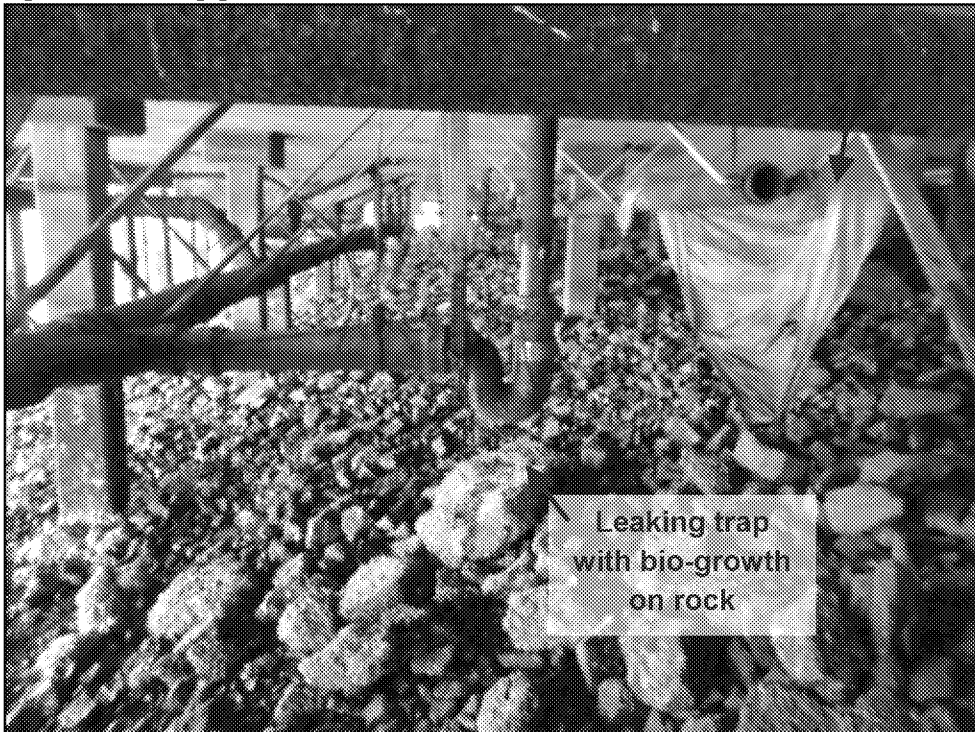
Photograph 14. View of a deteriorated pipe underneath the facility. The rock under the pipe was moist from leaking wastewater and appeared to have bio-growth in these areas. Plastic sheeting was also observed on nearby structures.
